**BACKGROUND**

**EFFECT OF STATIC ELECTRICITY ON THE AG2000**

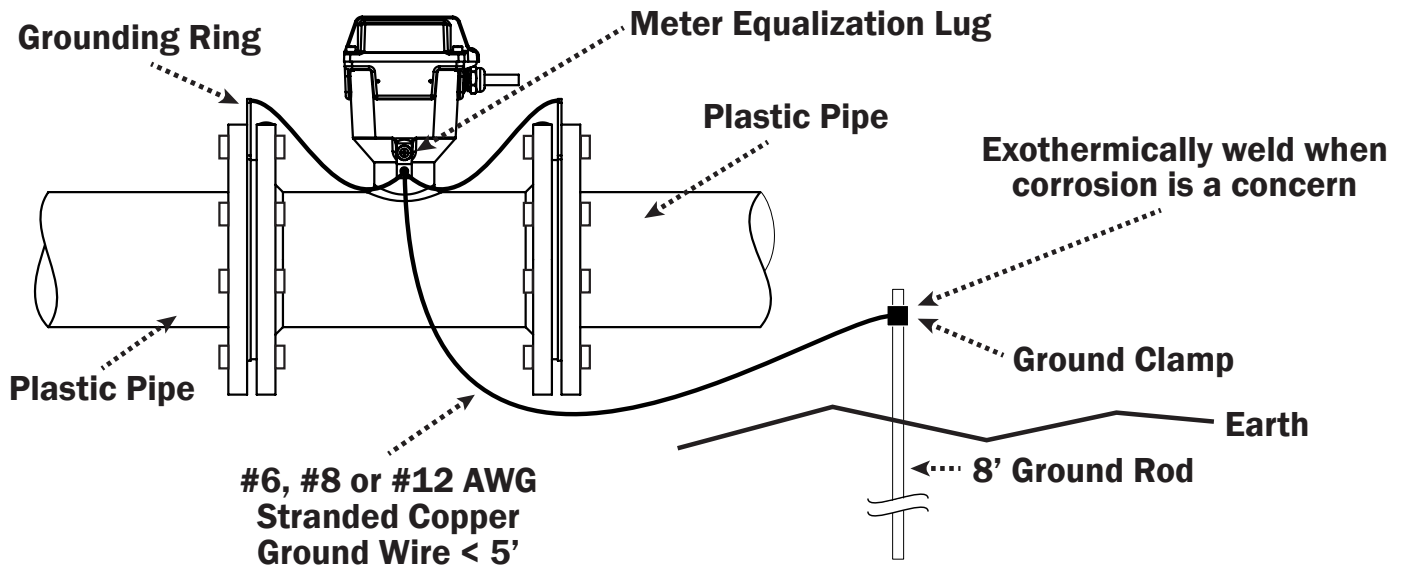
As the static electricity builds up across the electrodes, the high voltage may cause the processor to lock up, freezing the display or even causing it to go completely blank. In extreme cases, the processor may actually be damaged, requiring replacement of the AG2000.

When the AG2000 is installed in a plastic piping system, grounding rings may be required, especially in the presence of electrical interference sources such as VFD pump drives. As shown in the diagram below, the equalization wires should then be connected to the grounding ring tabs instead of the flange bolts as in metal piping installations. Where lightning is a threat, or in severe electrical environments, an optional connection to a nearby equipment ground or ground rod may be advisable.

**NOTE:** *In areas where corrosion is a concern, the ground wire should be exothermically welded to the ground rod.*
