Technical Bulletin WMX-Series/ iMAG In Plastic Piping

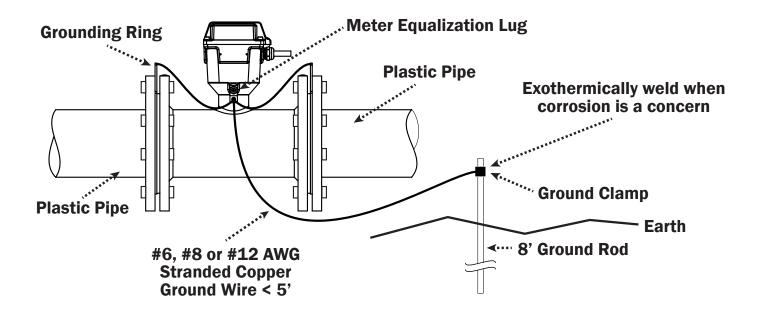
When a WMX or iMAG is installed in a plastic piping system, grounding rings may be required, especially in the presence of electrical interference sources such as VFD pump drives. As shown in the diagram below, the equalization wires should then be connected to the grounding ring tabs instead of the flange bolts as in metal piping installations. Where lightning is a threat, or in severe electrical environments, an optional connection to a nearby equipment ground or ground rod may be advisable.

NOTE: In areas where corrosion is a concern, the ground wire should be exothermically welded to the ground rod.
